Imaging Findings of 3-Dimensional Bioabsorbable Breast Implant Device

Miral M. Patel MD, Megha M. Kapoor MD, Marion E. Scoggins MD

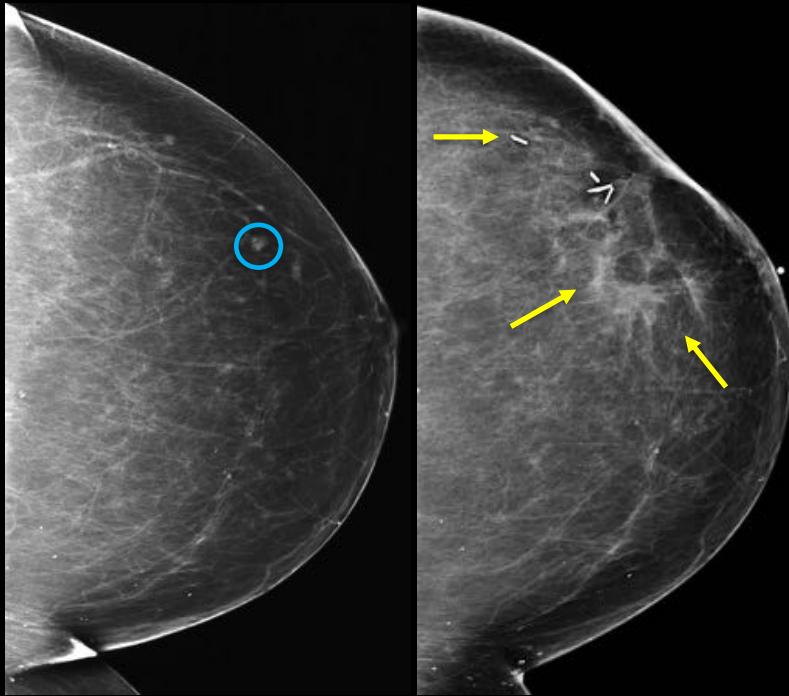
Breast conservation surgery (BCS)

74 year old status post BCS for left breast DCIS
Patient declined adjuvant radiation therapy

- (Left) Pre-biopsy craniocaudal (CC) view demonstrating **small irregular mass**
- (Right) Post-operative CC view shows expected postoperative changes including **post surgical scar and surgical clips located at the site of the original mass**

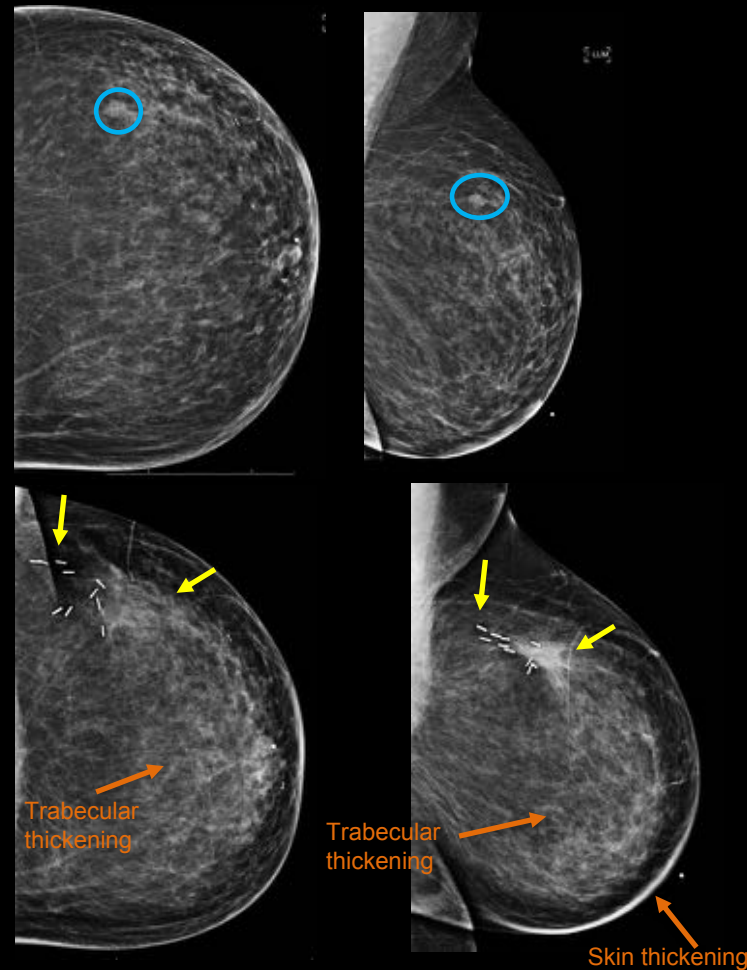
Breast conservation therapy (BCT)

46 year old status post BCT for invasive ductal carcinoma (IDC)

- (Top) CC and lateral pre-biopsy views demonstrate a **suspicious mass**
- (Bottom) CC and lateral views 6 months post radiation demonstrate **post-surgical scar and clips** located at the site of the original mass with **mild expected trabecular and skin thickening** related to radiation therapy

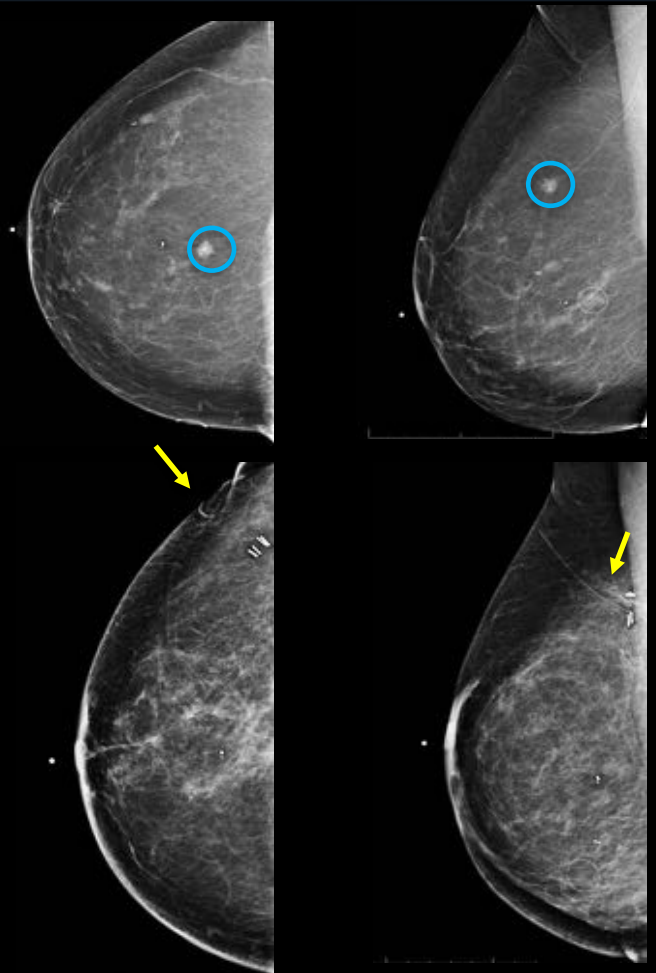
Oncoplastic Reconstruction

63 year old status post BCT for IDC with simultaneous reduction and tissue rearrangement

- (Top) CC and lateral pre-biopsy views demonstrate **small spiculated mass**. Additional benign biopsy clips noted.
- (Bottom) CC and lateral views post oncoplastic reconstruction demonstrate **scar marker and clips away from original tumor bed**

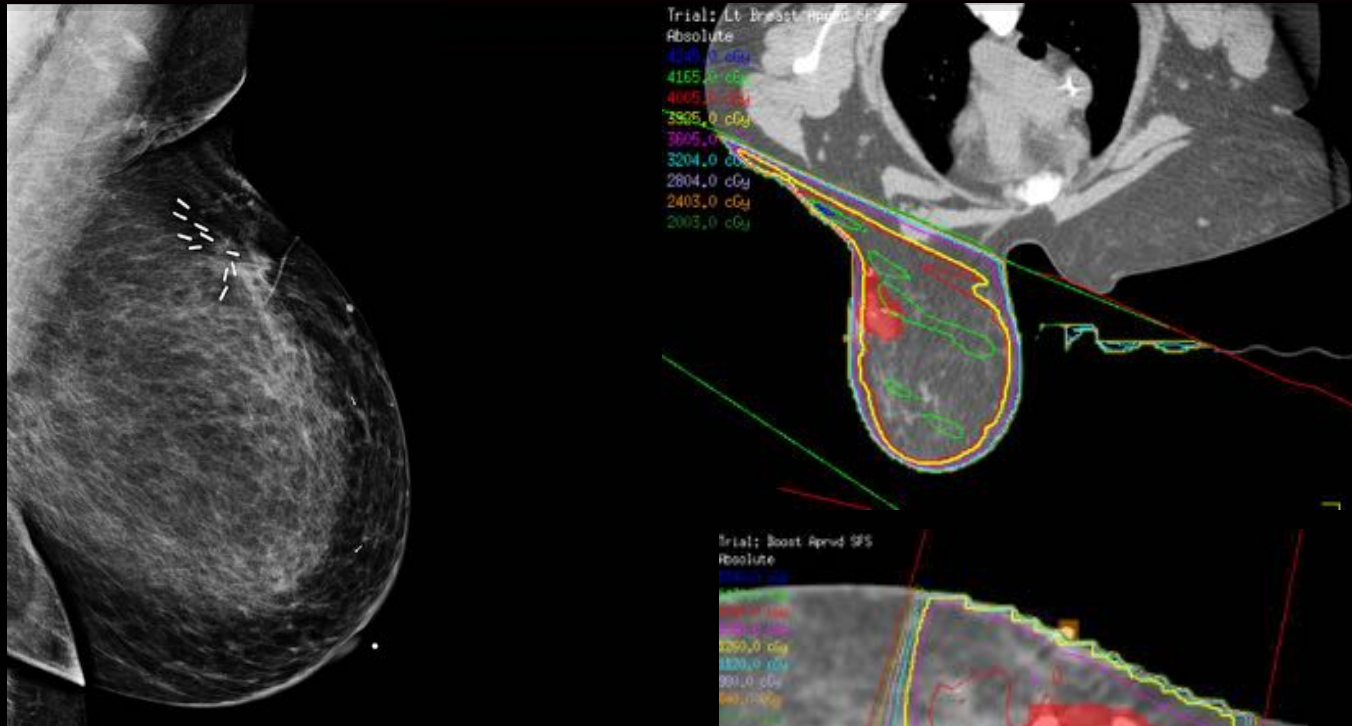
Radiation Treatment Planning

46 year old status post BCT for IDC, 6 month post radiation baseline mediolateral oblique (MLO) view (above)

- Patient received hypofractionated WBI and boost to tumor bed
- (Top Right) Image demonstrates radiation treatment plan for WBI. Note targeting of the post-surgical clips seen on mammography.
- (Bottom Right) Image demonstrates radiation treatment plan for 'boost' to tumor bed. Again, note targeting of the post-surgical clips seen on mammography.

- Goal: deliver prescribed dose in a homogeneous distribution and minimize exposure and dose to critical structures
- Simulation using CT guidance is used to map out the radiation field and dose at various areas
 - Boards, cradles or molds allow reproducibility of positioning over the course of treatment
- Typically, radiation oncologists use the visible findings of post-surgical change including scar, post-surgical clips, and/or seromas to specifically target the tumor bed
- With oncoplastic reconstruction at the time of initial surgery becoming more common, the visible findings of post-surgical change may not correspond with the tumor bed, making targeting of the tumor bed difficult

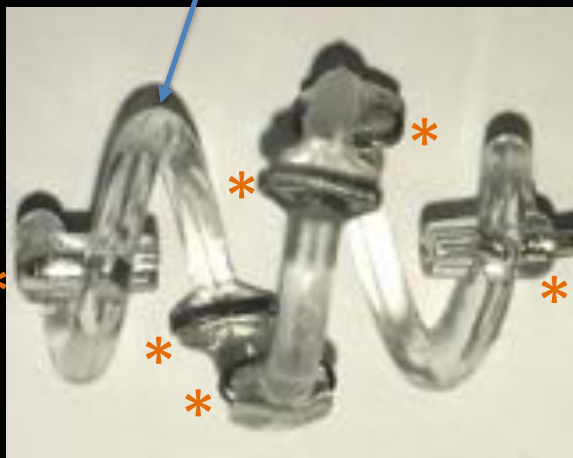
3-D bioabsorbable spiral frame

6 titanium marker clips (indicated by *)

- The device is a marker sutured into the surgical cavity at the time of lumpectomy
- The six titanium clips of the BioZorb® device are radiopaque and therefore easily recognized on mammography, chest radiography and CT examination based on their unique configuration

- In order to better delineate the lumpectomy cavity, surgeons and radiation oncologists are now using a bioabsorbable 3D breast implant device called the BioZorb®

- Assists in delineating tumor bed on follow-up imaging when evaluating for recurrence
- The device serves as a target for radiation treatment, particularly in the setting of BCS with oncoplastic reconstruction where the surgical clips and scar may not match the original tumor bed

- The device also serves as an initial scaffold to improve cosmetic outcomes with radiation (reduce retraction) and is designed to eventually absorb into the body (over the course of several years)

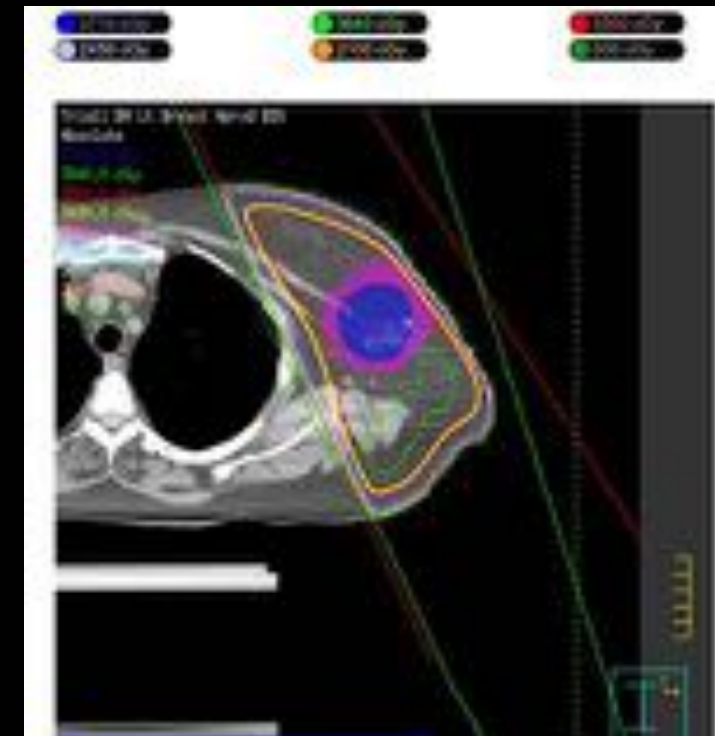
Image (below) demonstrates a radiation treatment plan in a patient with a BioZorb® device (note the blue circle indicating maximum radiation dose covering the BioZorb® device)

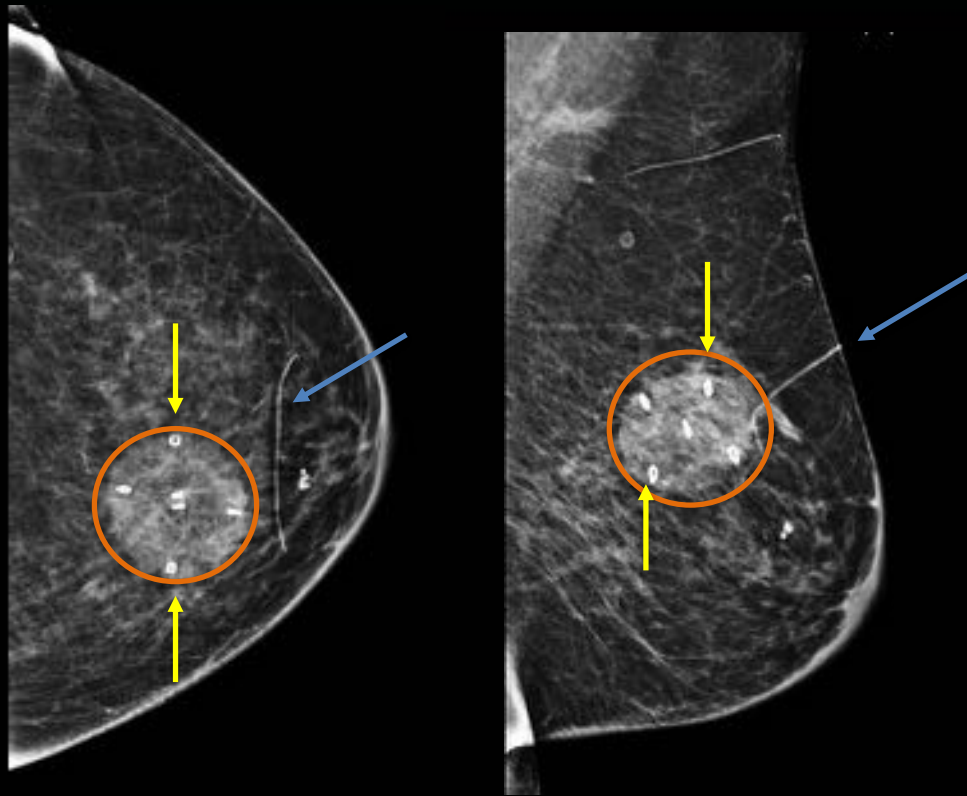
Initial post-surgical baseline mammography (CC and MLO views) demonstrates a **post-surgical scar** with **six well-spaced radiopaque titanium clips** in a **well-circumscribed, oval, equal density mass**.

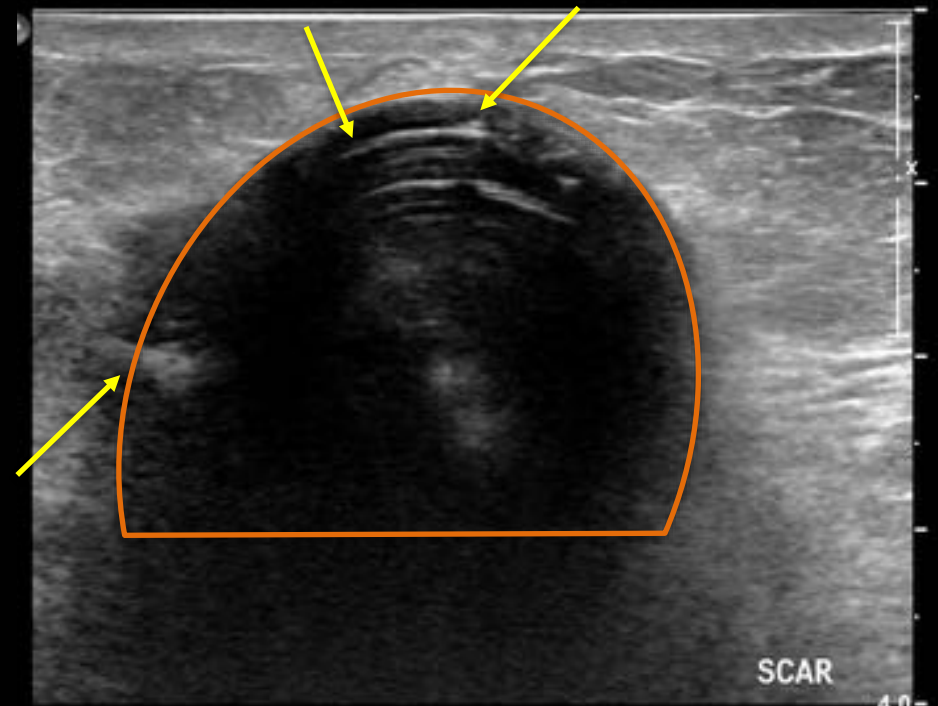
Initial post-surgical baseline ultrasound performed the same day demonstrates a post-surgical scar with an **area of shadowing** and associated **linear echogenic areas** similar to artifact seen with clips

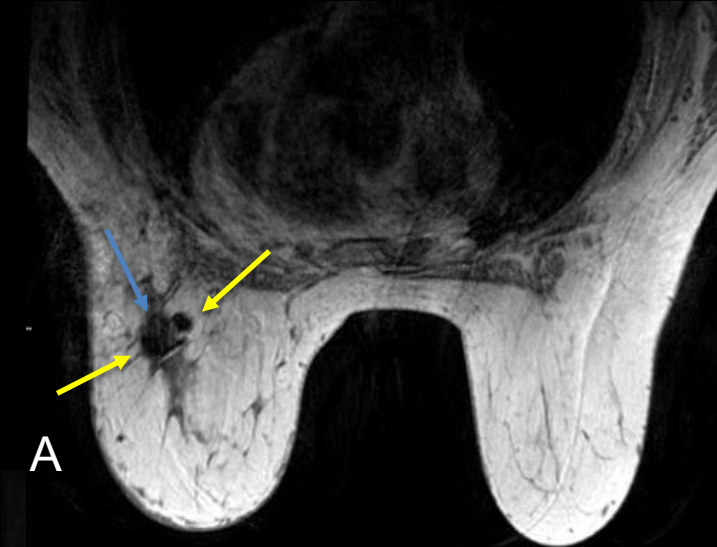
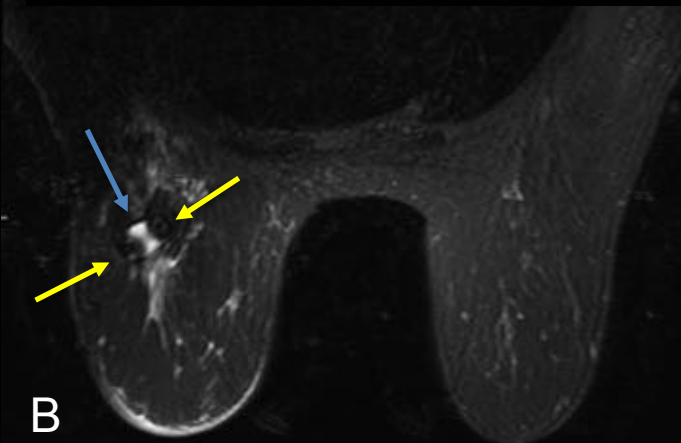
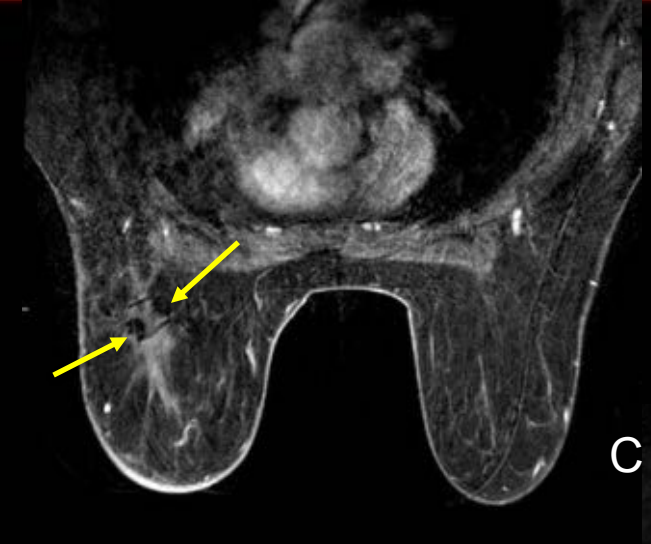
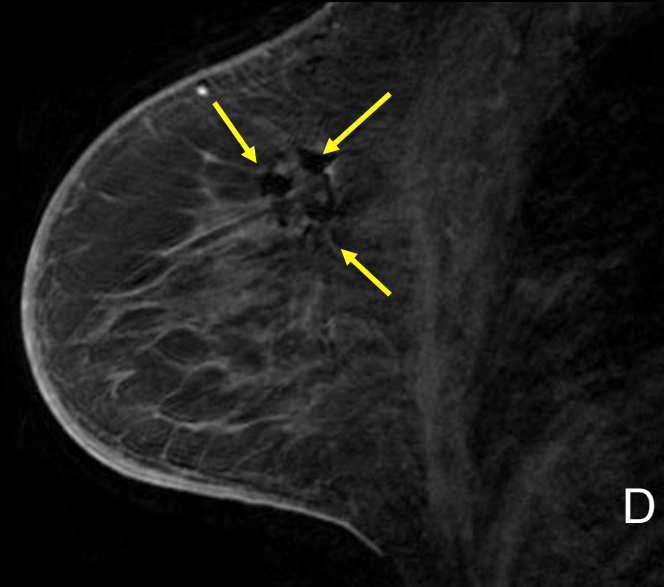
Normal Postoperative Imaging Findings: Breast MRI

64 year old with history of left segmental mastectomy for metaplastic carcinoma and DCIS 1 year ago.

A. Axial T1-weighted image demonstrates post-surgical change with **two susceptibility artifacts** related to two of the six marker clips related to the BioZorb®

B. Axial T2-weighted image demonstrates **hyperintense signal related to post-surgical changes** with **two susceptibility artifacts** related to two of the six marker clips

C. Axial T1-weighted fat saturated post contrast image again demonstrates **susceptibility artifact** related to the BioZorb® clips with no abnormal enhancement of the surgical bed

D. Sagittal delayed post contrast T1-weighted fat saturated image demonstrates **susceptibility artifact** related to three of six marker clips arranged in the **typical helical configuration** with no abnormal enhancement of the surgical bed

- The “spokewheel” configuration of the device can also be recognized on postoperative CT and MR images which should demonstrate no abnormal enhancement.

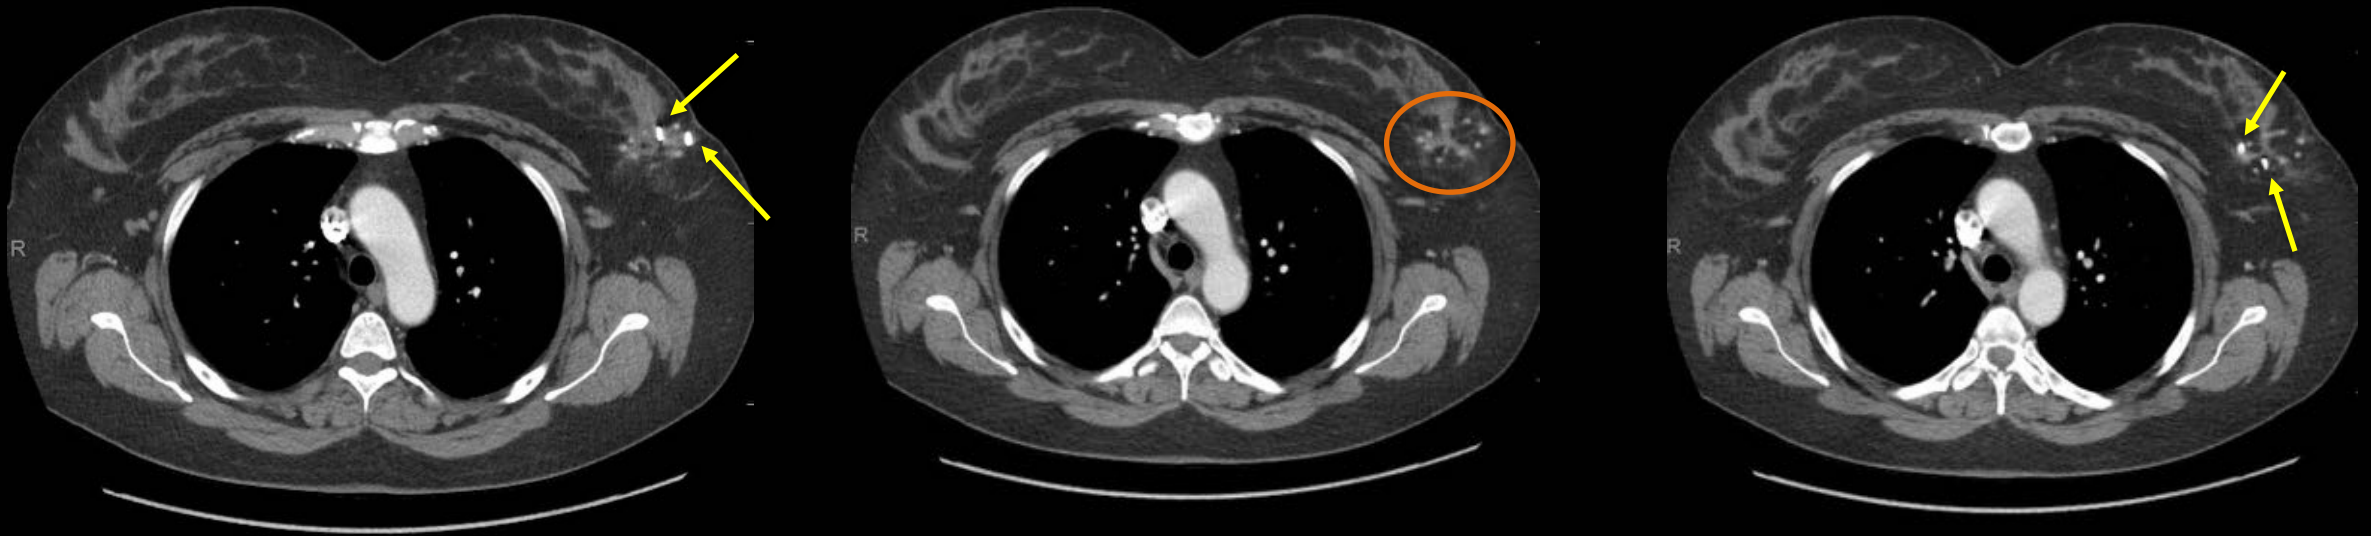
Normal Postoperative Imaging Findings: CT Chest

Status post BCT approximately 1 year postop:

Post contrast axial CT images of the chest from superior to inferior (left to right) demonstrate the expected CT appearance of the BioZorb® device as **radio-opaque titanium clips** arranged in a “**spokewheel**” configuration with interspersed fat. This unique configuration helps to differentiate the device from artifact related to other titanium marker clips placed in the breast.

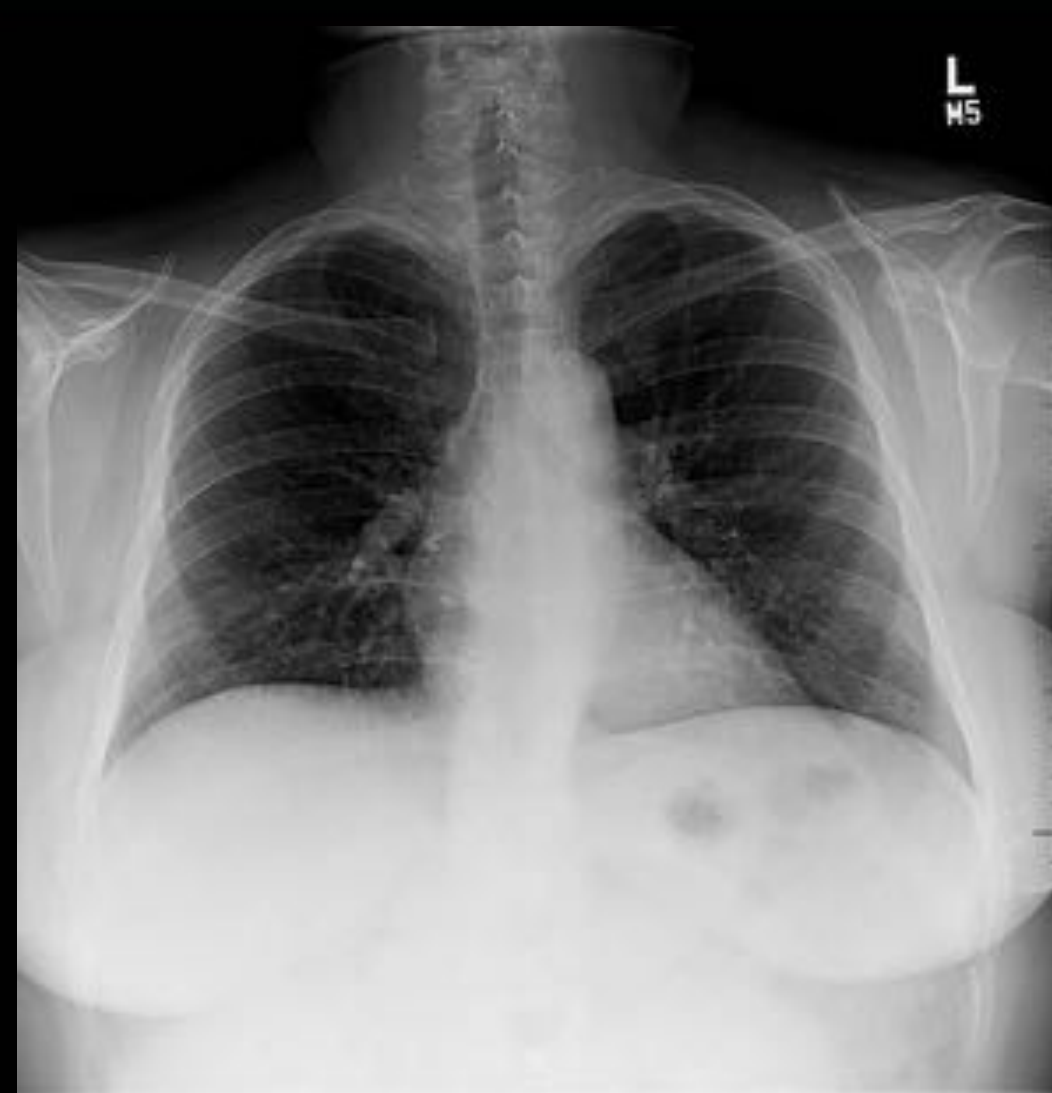
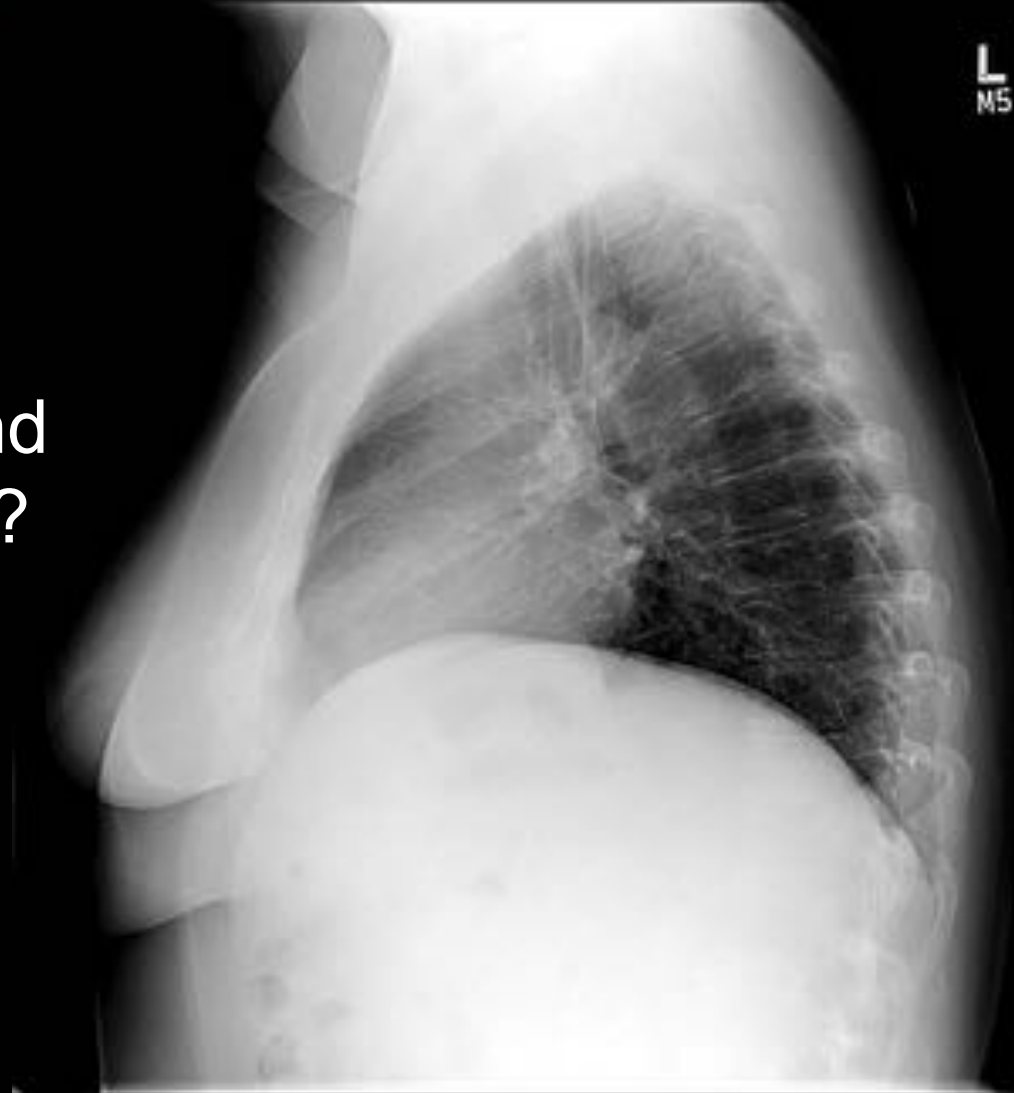
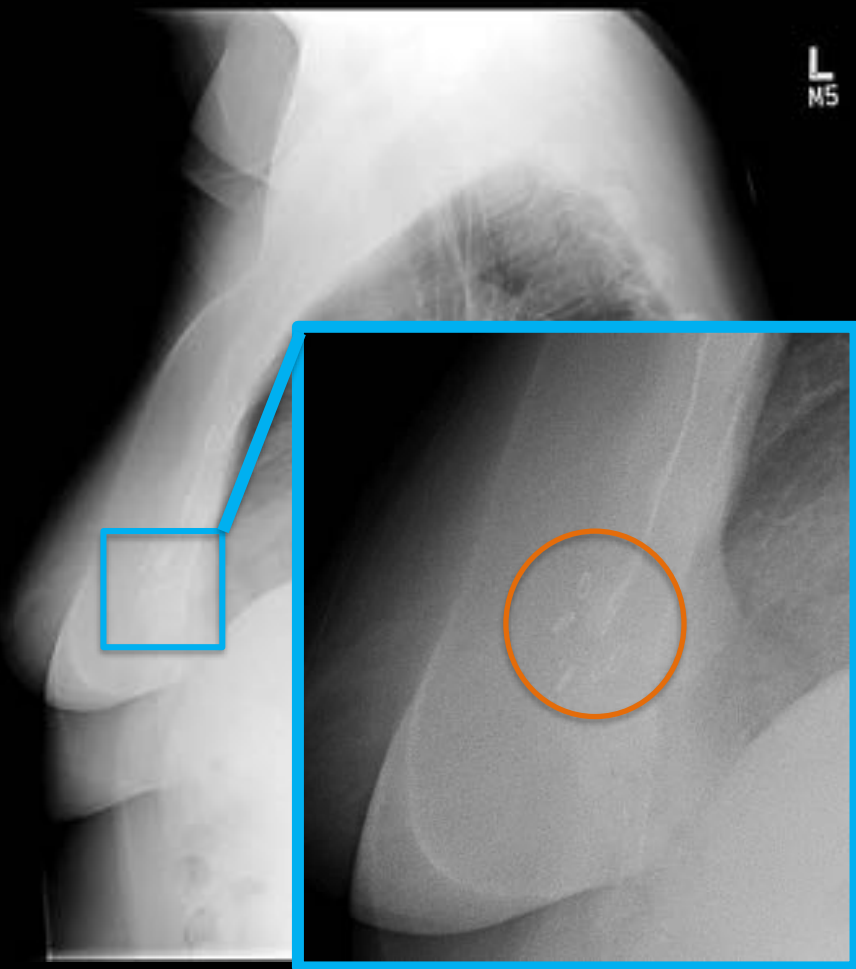
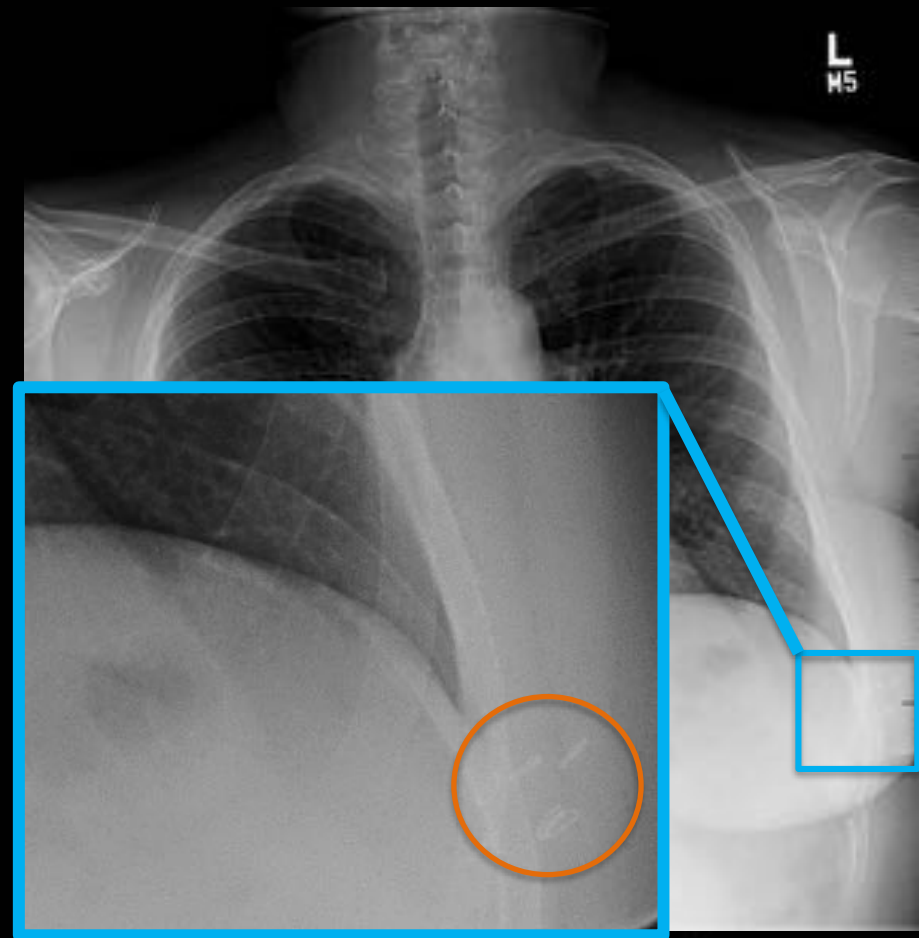
Normal Postoperative Imaging Findings: Chest Xray

Status post BCT
approximately 1 year postop:

Lateral and posteroanterior (PA) radiographs and magnified views of the chest demonstrate the expected “**spokewheel**” configuration of six radiopaque titanium marker clips located **within the soft tissues of the left breast** consistent with the BioZorb®

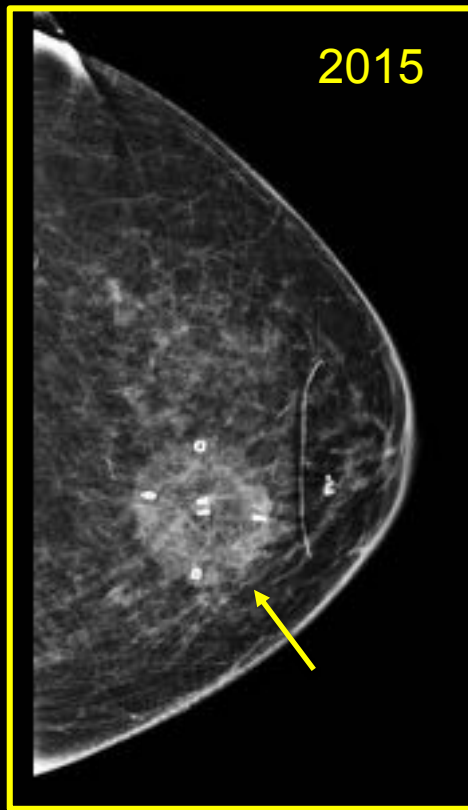
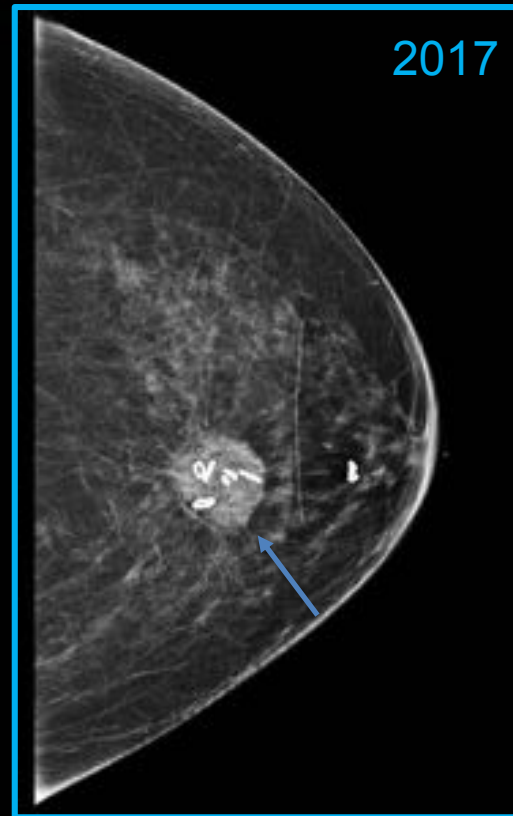
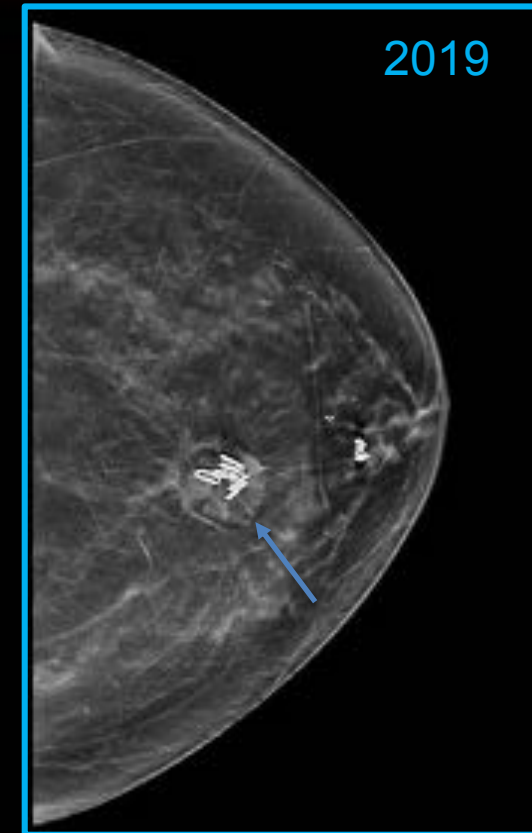
Normal Evolution on Postoperative Imaging: Mammogram

Initial post-surgical baseline mammogram and subsequent follow-up examinations over the course of 4 years (CC views) demonstrate **well-spaced titanium clips in a well-circumscribed, oval, equal density mass on initial imaging.** Over the course of follow-up, the expected evolution on mammography is a decrease in size of the oval mass with less space noted between the titanium marker clips.

- As the device is expected to slowly absorb, the normal evolution on imaging demonstrates decreased space between the six radiopaque markers and a gradual shift to a more isoechoic appearance on sonography without associated increased vascularity.

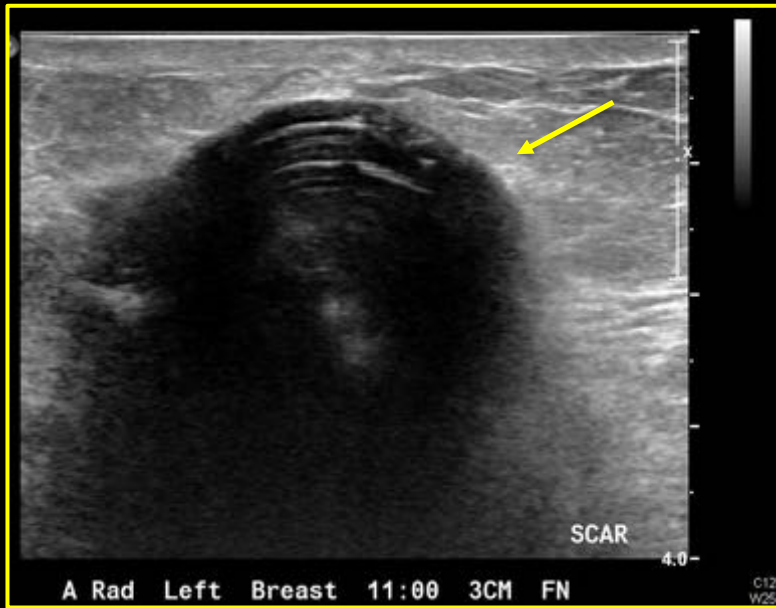
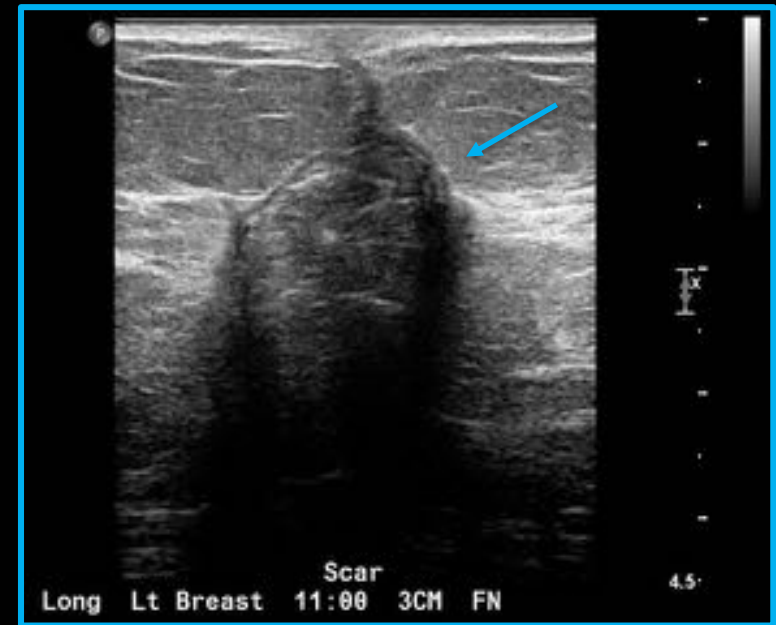
Normal Evolution on Postoperative Imaging: Ultrasound

Similar associated findings are identified sonographically in the same patient, with the **initial baseline ultrasound demonstrating an oval area of shadowing at the scar and echogenic lines associated with BioZorb® device**, with subsequent decrease **in size of the area of shadowing which begins to demonstrate an isoechoic appearance**. No associated increased vascularity was identified.

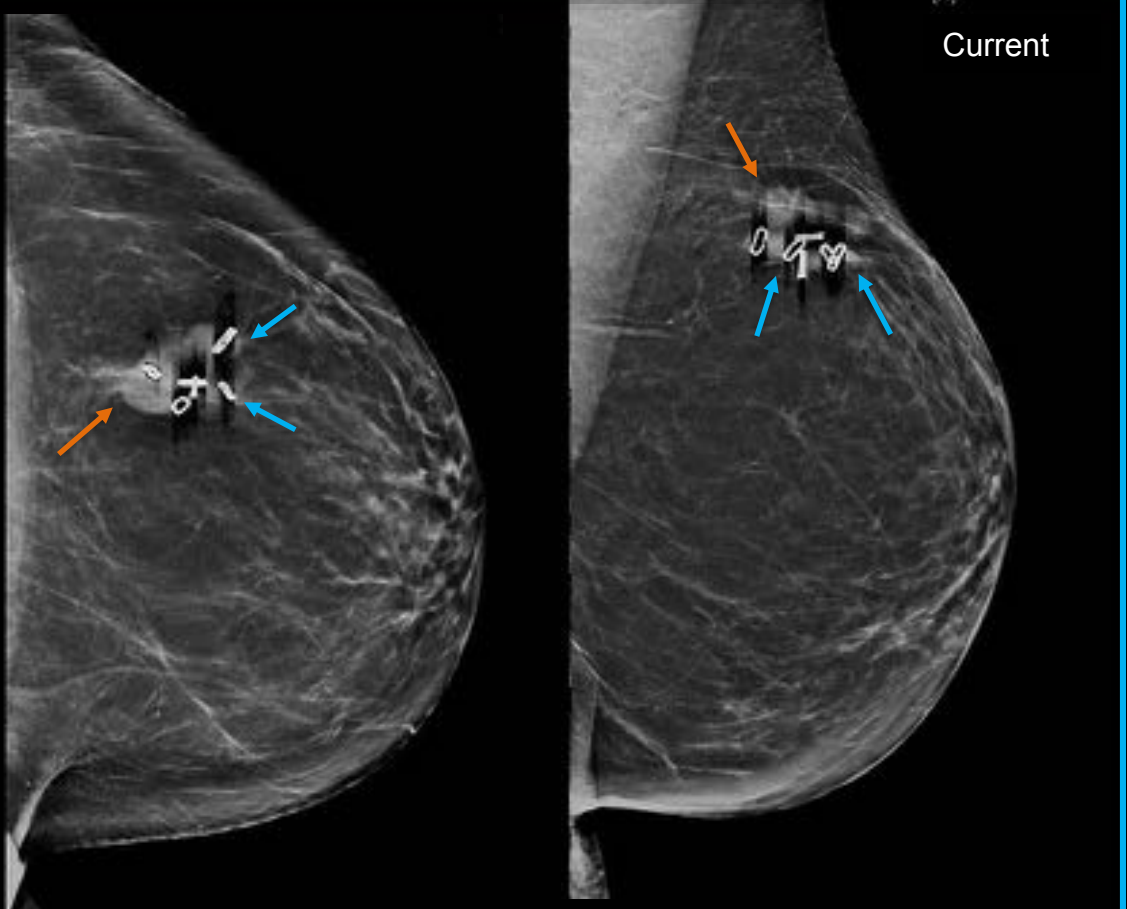
Case 1: 64 year old with history of invasive breast cancer 3 years ago presenting for annual examination

Current CC and lateral C-view images demonstrate expected evolution of the BioZorb® device with focal asymmetry at the superoposterior aspect of the device

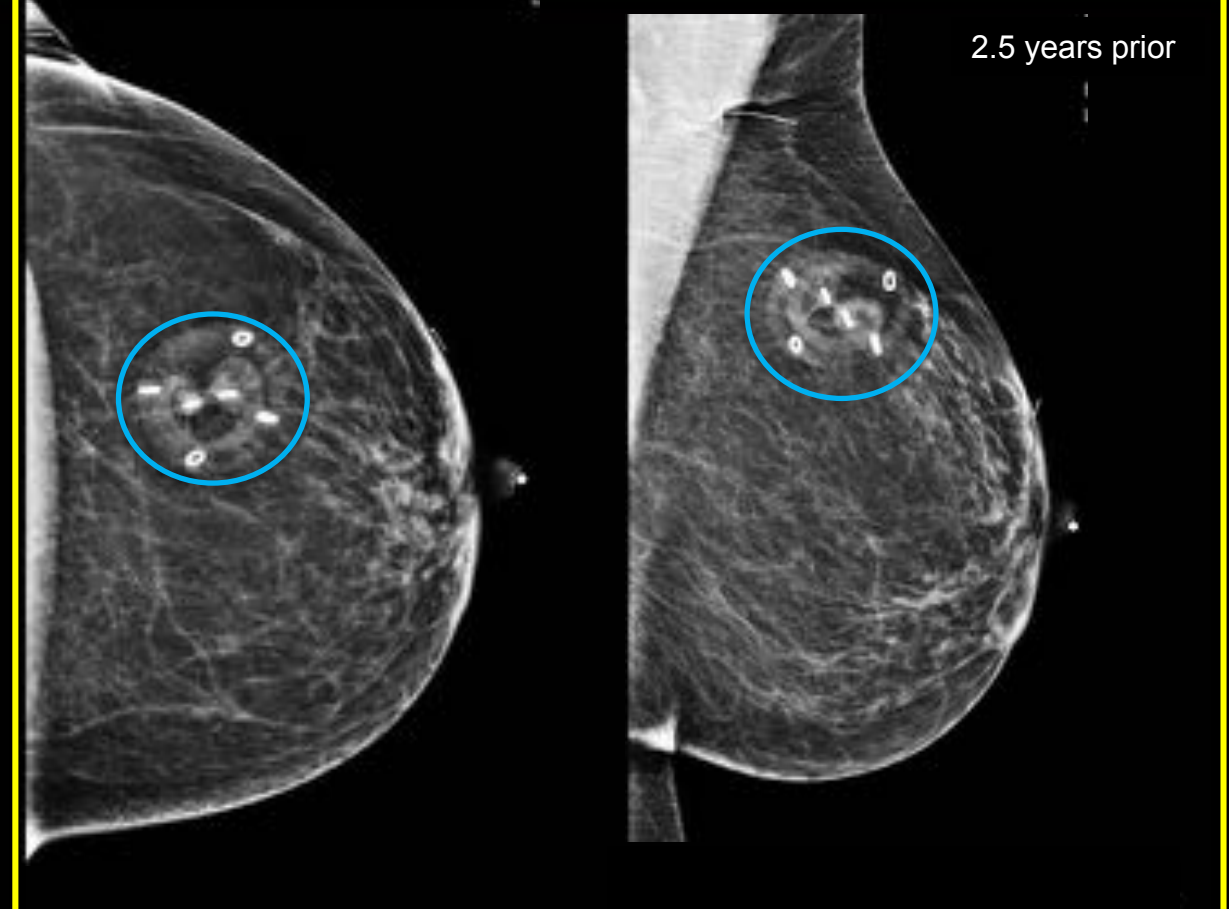
Initial postoperative baseline CC and lateral images demonstrate expected postoperative appearance of the BioZorb® device with no suspicious findings

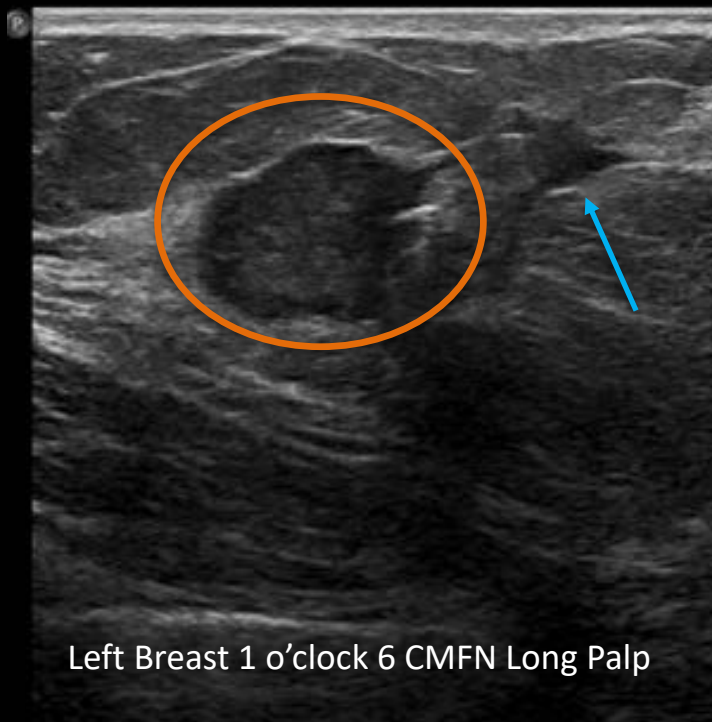
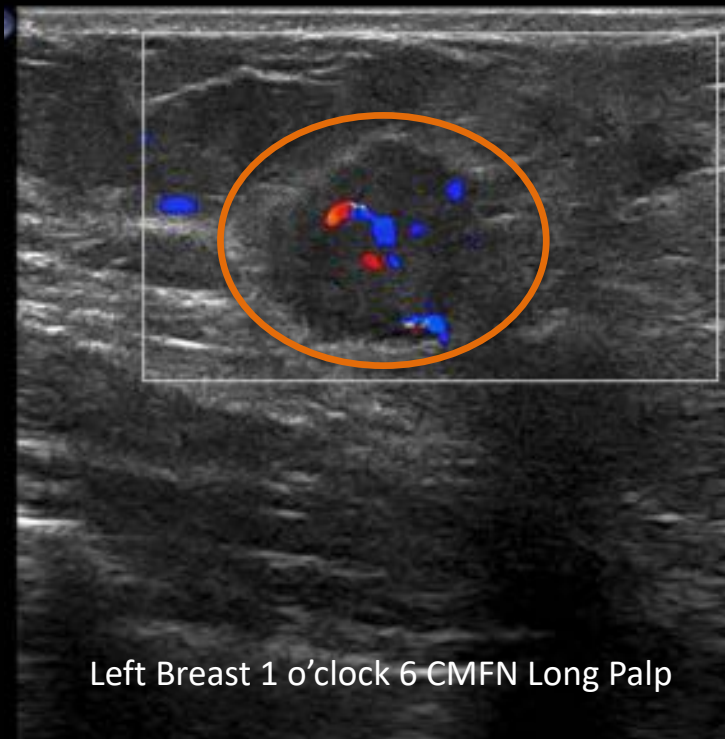
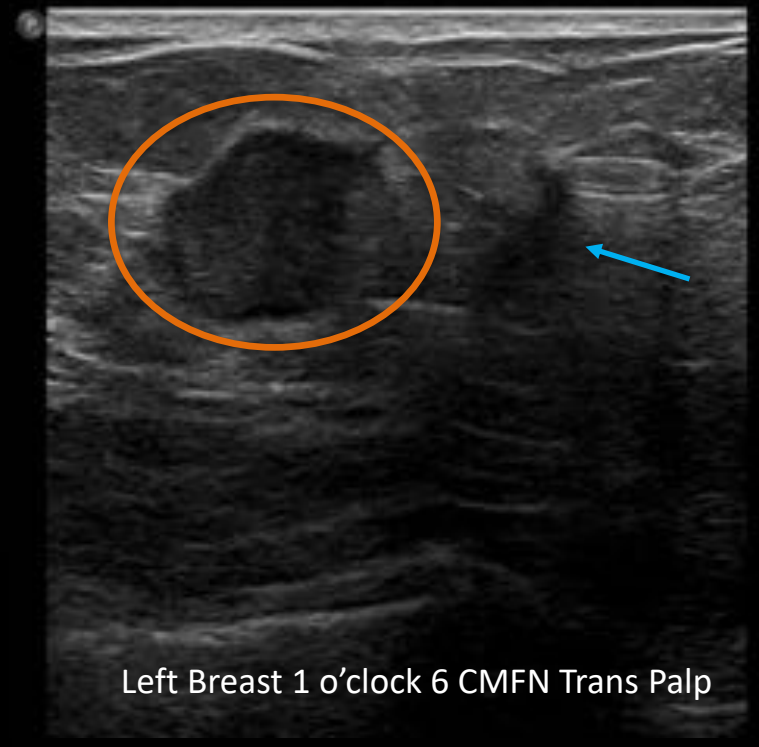
At the time of diagnostic ultrasound examination, the patient reports she has noted the area is becoming more “full” over the years.

Grayscale longitudinal and transverse images (left and right) along with color Doppler image (center) demonstrate correlating **irregular hypoechoic mass with increased color Doppler flow** in close proximity to the edge of post-surgical change related to the BioZorb®

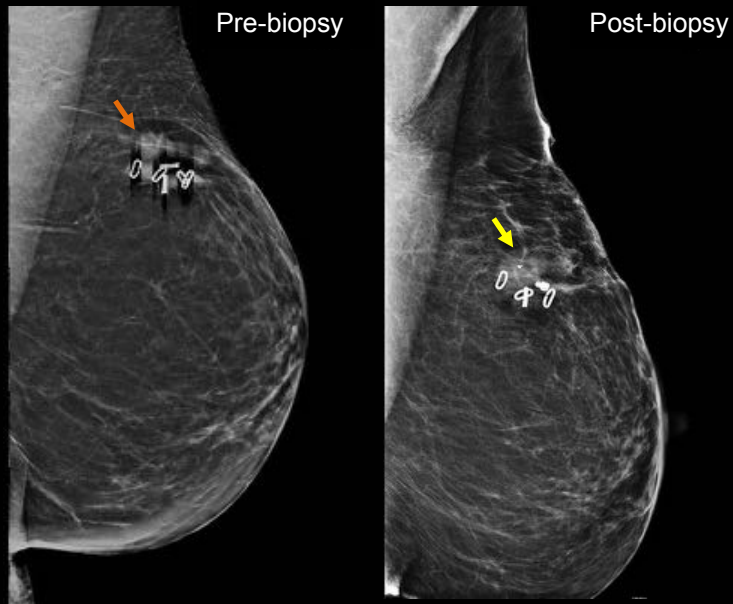
Biopsy was performed under sonographic guidance at outside facility with marker clip placement. (Below) Pre biopsy lateral view with previously noted **suspicious focal asymmetry** and post biopsy MLO view demonstrates **biopsy marker clip within the mammographic focal asymmetry**.

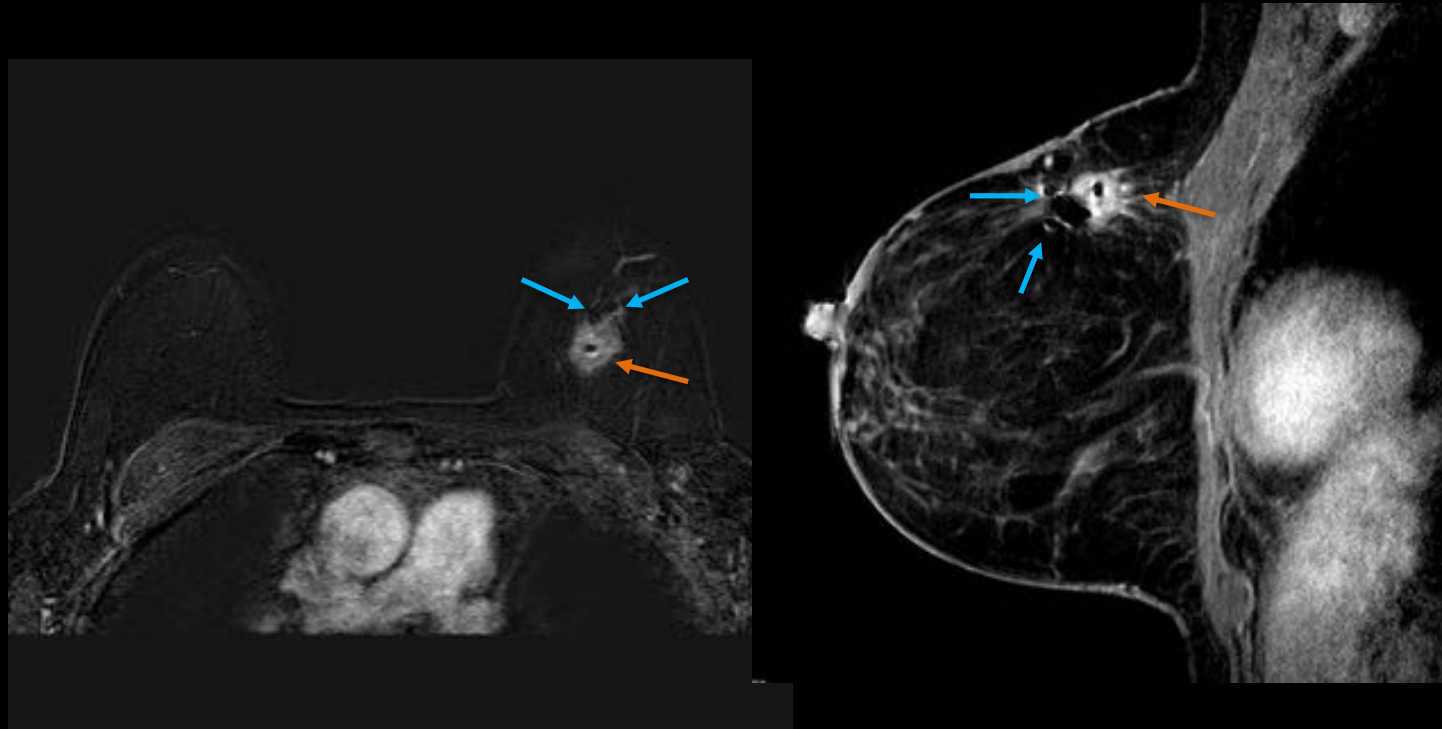
Subsequent breast MRI was performed two months after biopsy. (Below) Axial post contrast subtraction image (left) and delayed sagittal post contrast T1-weighted fat saturated images demonstrate an **irregular enhancing mass with internal clip** located posterior to the **expected susceptibility artifact from the BioZorb® device**.

- Increased eccentric density on mammography with correlating solid and hypervascular mass on sonography and abnormal enhancement on MRI are expected findings in the setting of local recurrence.
