Imaging Findings of 3-Dimensional Bioabsorbable Breast Implant Device

Miral M. Patel MD, Megha M. Kapoor MD, Marion E. Scoggins MD

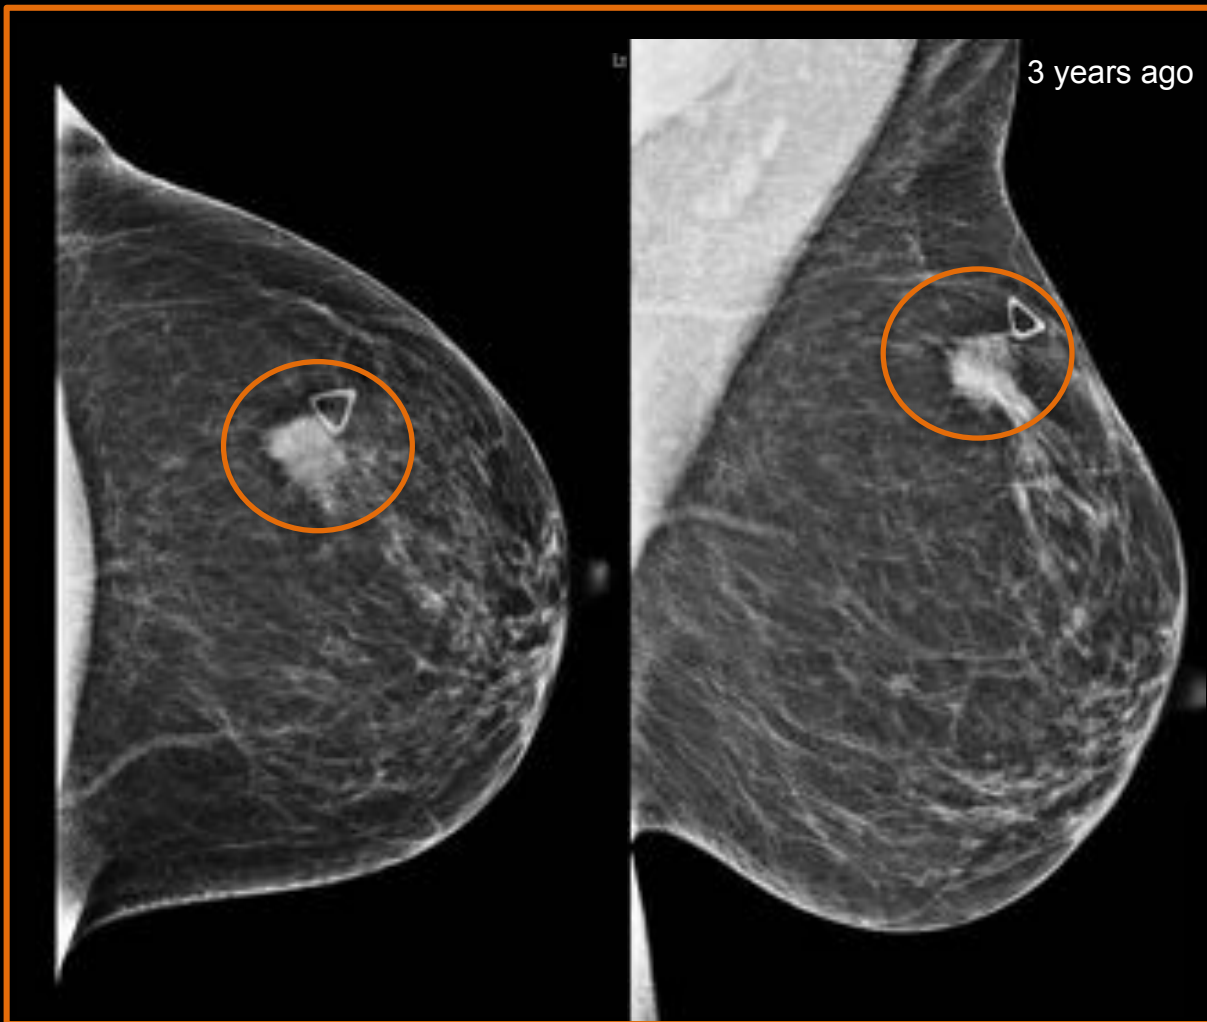
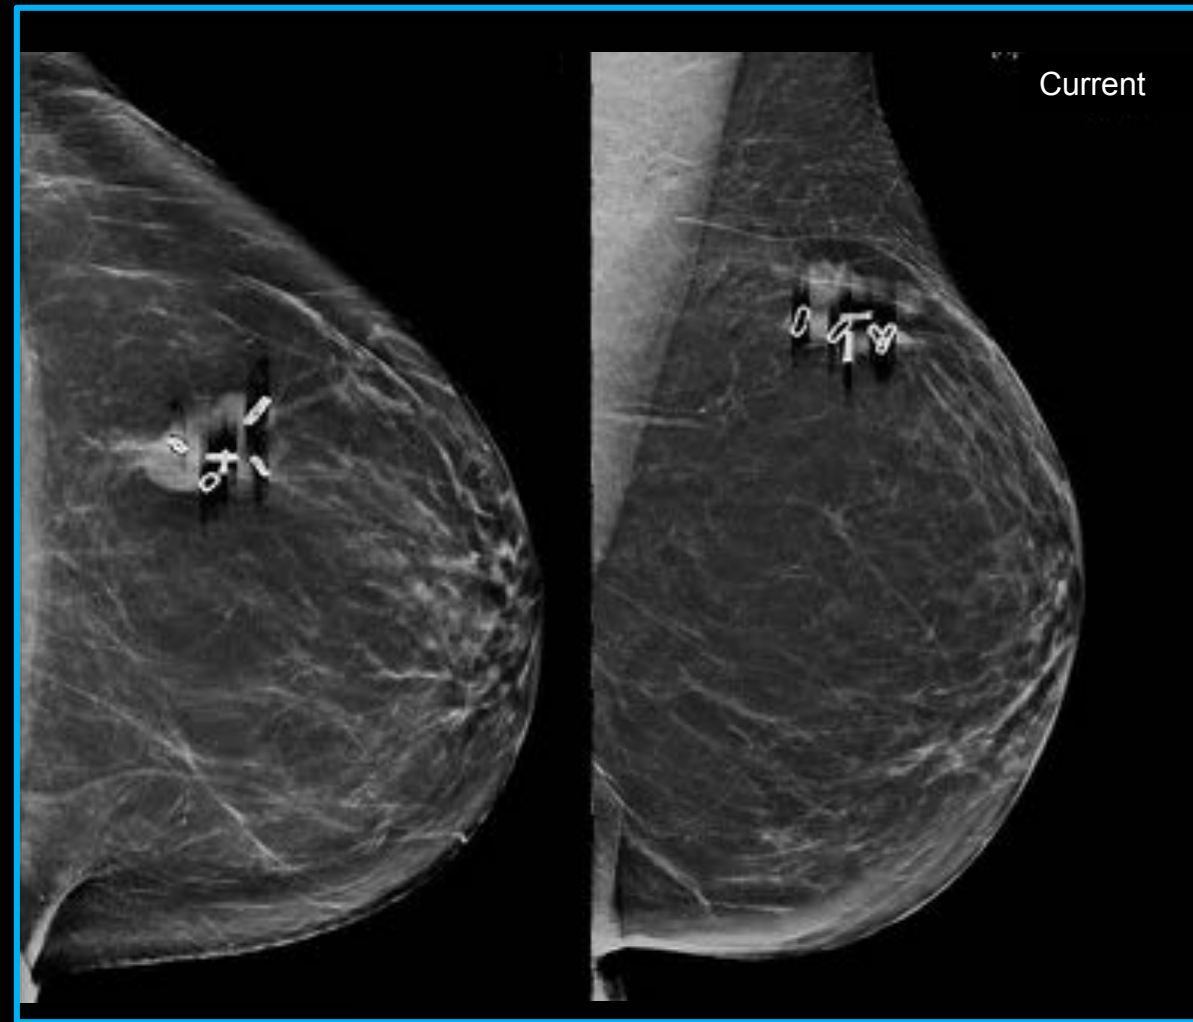
Same patient reviewing remote priors: Initial CC and MLO (bottom left) mammogram images from original cancer diagnosis 3 years ago demonstrated a **high density, irregular, spiculated mass with associated palpable marker** in a similar location to the area of biopsy proven recurrence.

(CC and lateral C-view images of the current mammogram are again presented in the bottom right for comparison)

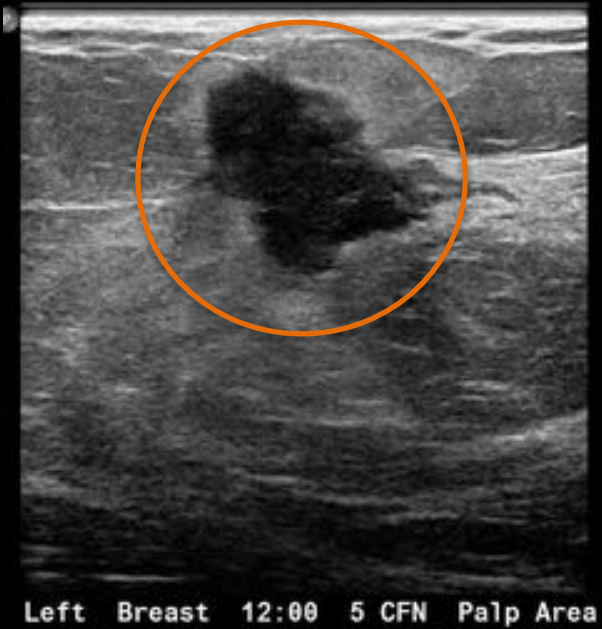
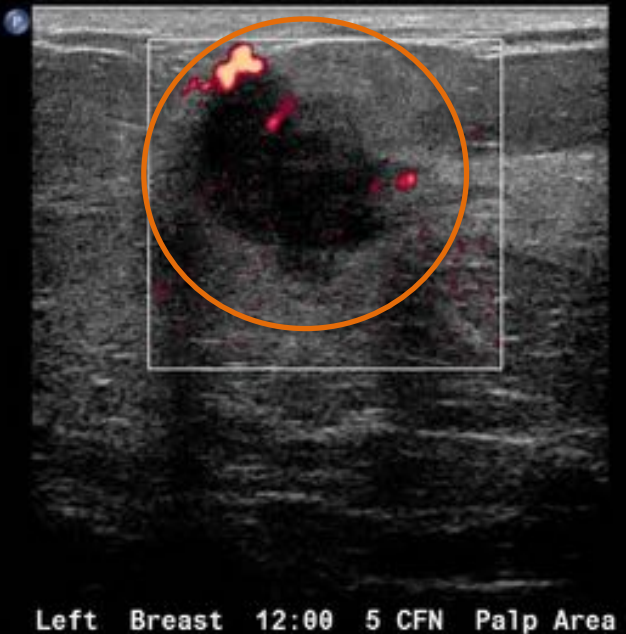
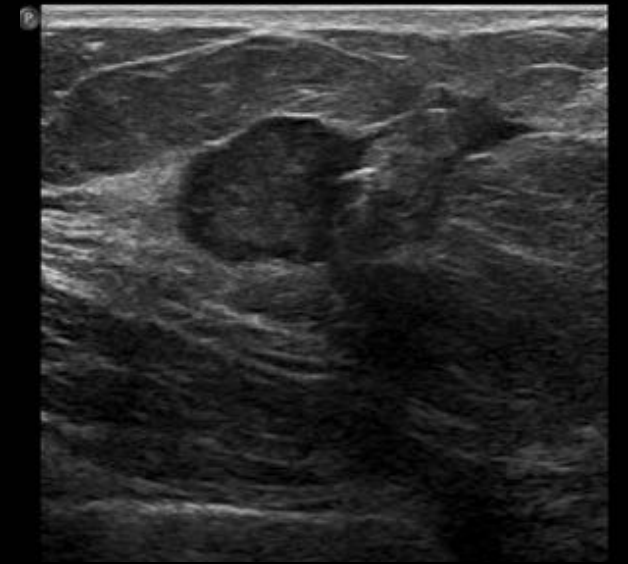
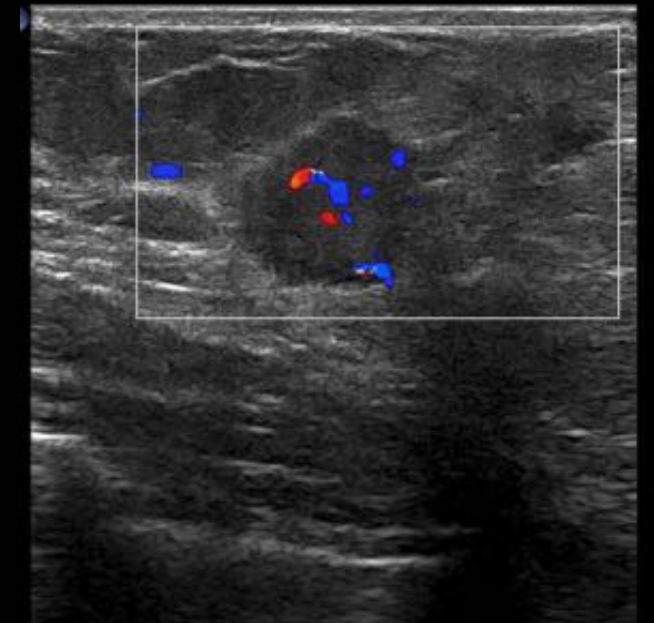
Initial Gray-scale ultrasound images (left) from original cancer diagnosis 3 years ago demonstrate an **irregular, hypoechoic mass with increased power Doppler flow** correlating with the palpable area in a similar location and with similar sonographic appearance to the area of biopsy proven recurrence (right).

(Gray-scale and color Doppler images of the current ultrasound are again presented on the right for comparison).

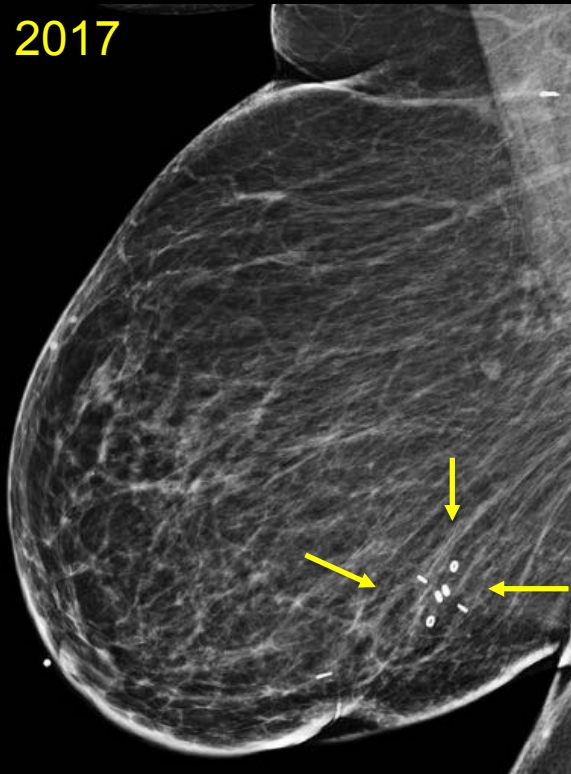
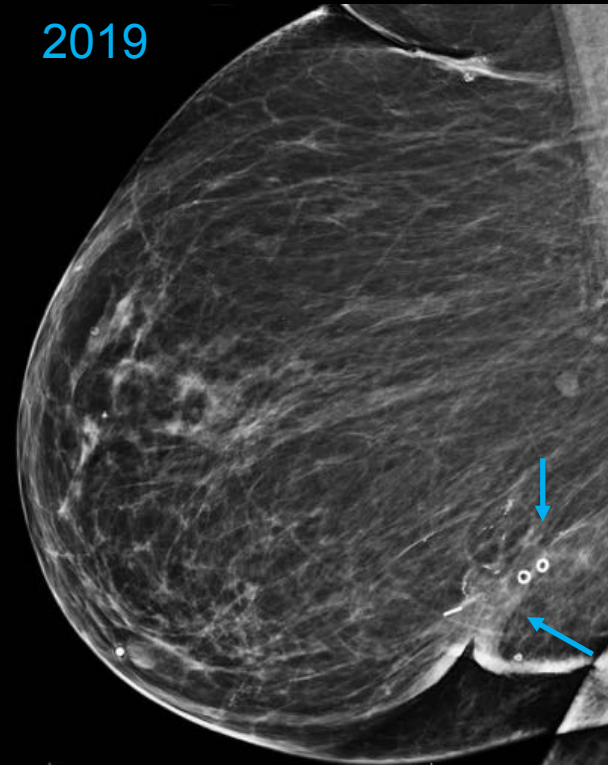
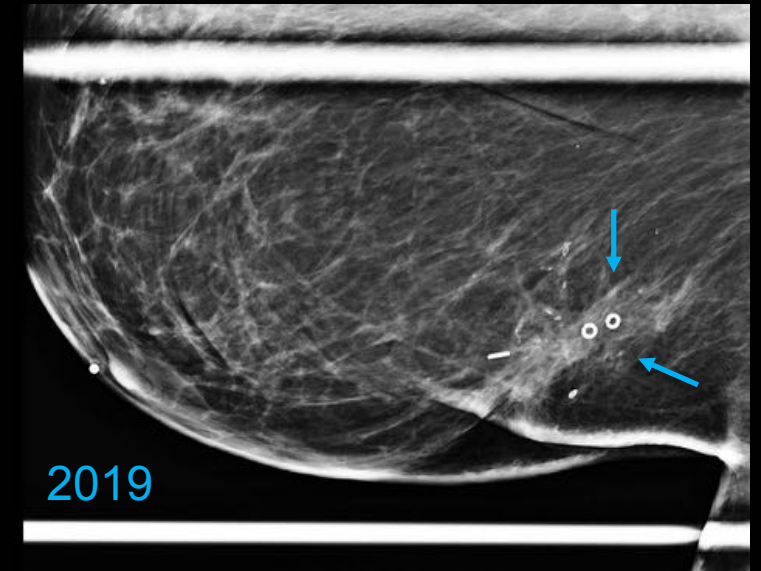
Case 2: 72 year old with history of right segmental mastectomy in August 2017 for invasive and in situ ductal carcinoma, completed radiation therapy in October 2017, noting open wound and drainage of pus and blood near the post-surgical site for approximately 2 months

Initial 2017 lateral-medial (LM) view demonstrates expected postoperative change with BioZorb® device. Current LM full field and spot compression mammography images demonstrate new asymmetry associated with the BioZorb® device.

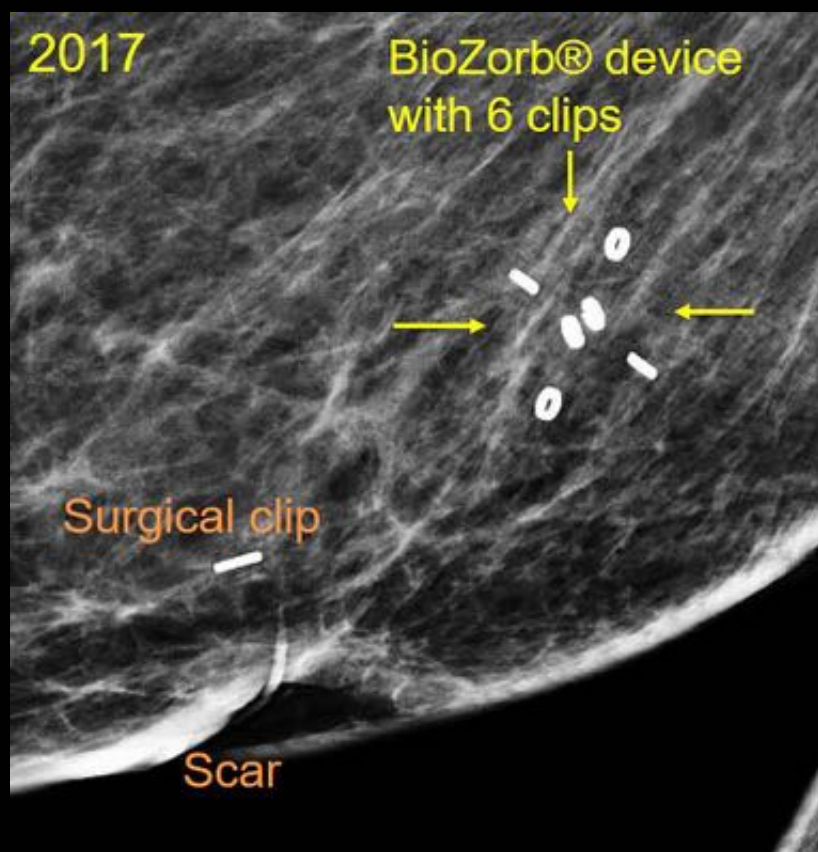
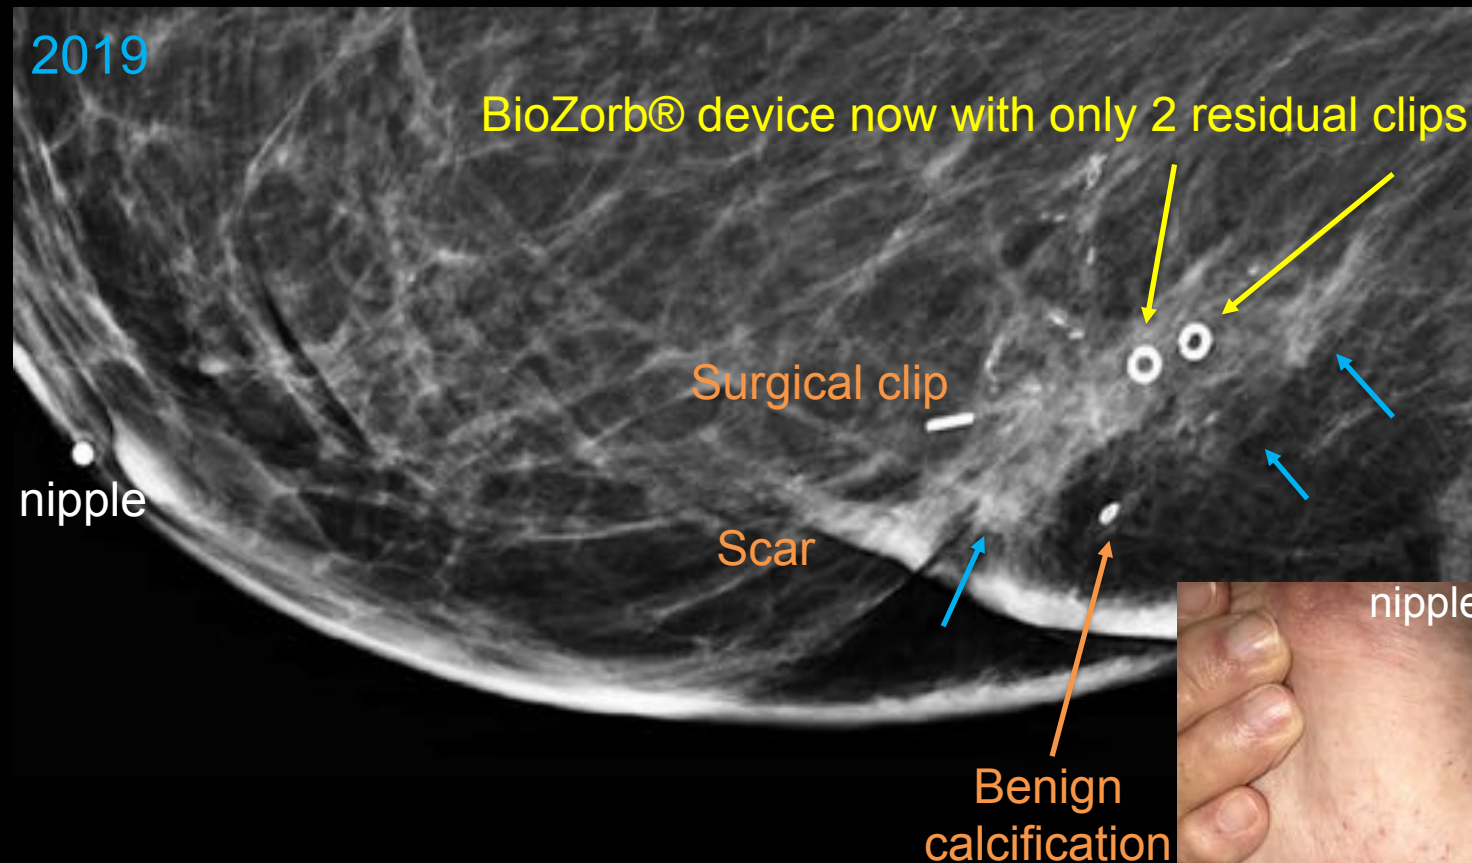
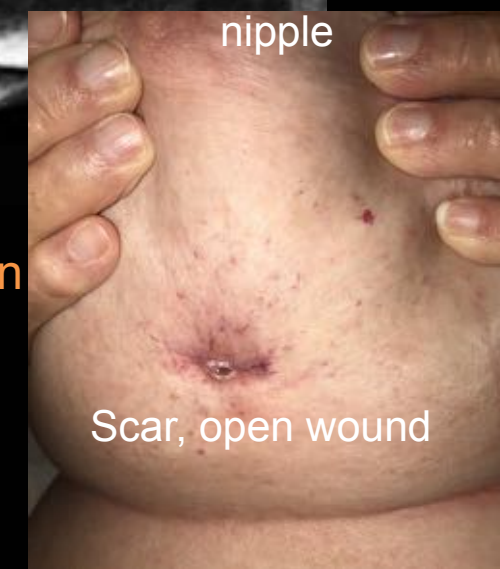
Initial 2017 zoomed in LM mammogram view (top left) demonstrates expected postoperative change with BioZorb® device. Current zoomed in LM spot compression mammography image (top right) again demonstrates new asymmetry (blue arrows) with four of six BioZorb® clips missing. The photograph (right) demonstrates the open wound noted along the inferior breast at the time of current diagnostic examination.

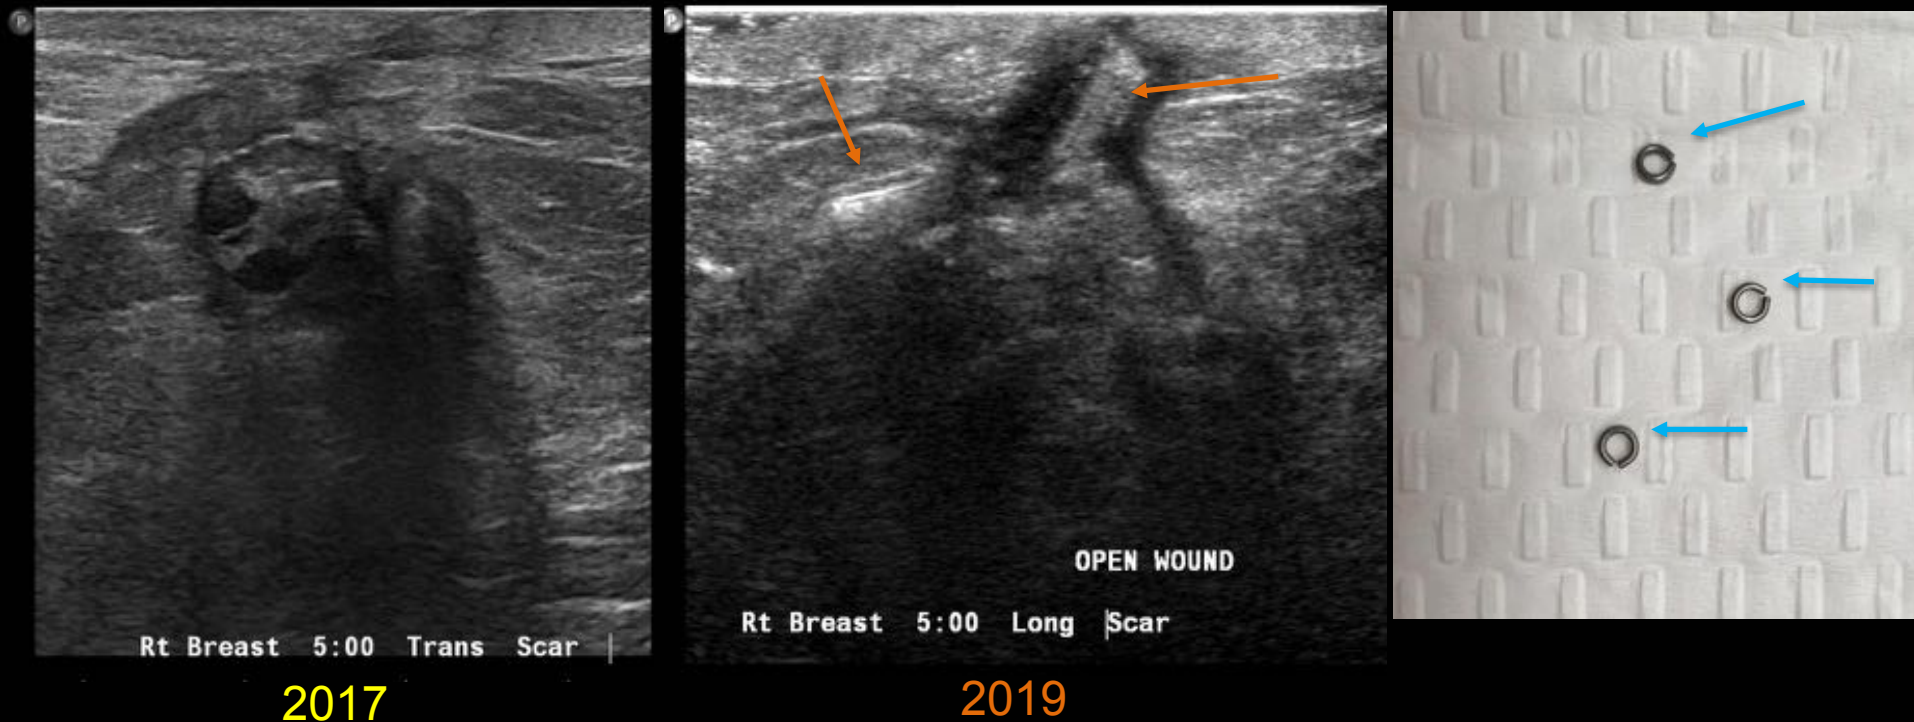
US images from 2017 (normal expected postoperative change associated with the BioZorb®) and currently demonstrating the change in the patient's scar and associated BioZorb® device which is now extruding through the open wound in the skin. Patient collected several of the clips from the BioZorb® that were extruding through her breast.

The patient was evaluated by surgery and findings were felt to be infected seroma or fat necrosis which drained through the scar. Patient was monitored with subsequent healing of the wound on clinical examination.
